Contract No. DTRS56-03-T-0003
5th Quarterly Status Report (Project #1) - REVISED
Period: April 1, 2004 to June 30, 2004

Quarterly Status and Progress Report
Improvements to the External Corrosion Direct Assessment
Methodology by Incorporating Soils Data
Agreement DTRS56-03-T-0003
5th Quarterly Status Report - *Revised*
April 1, 2004 to June 30, 2004

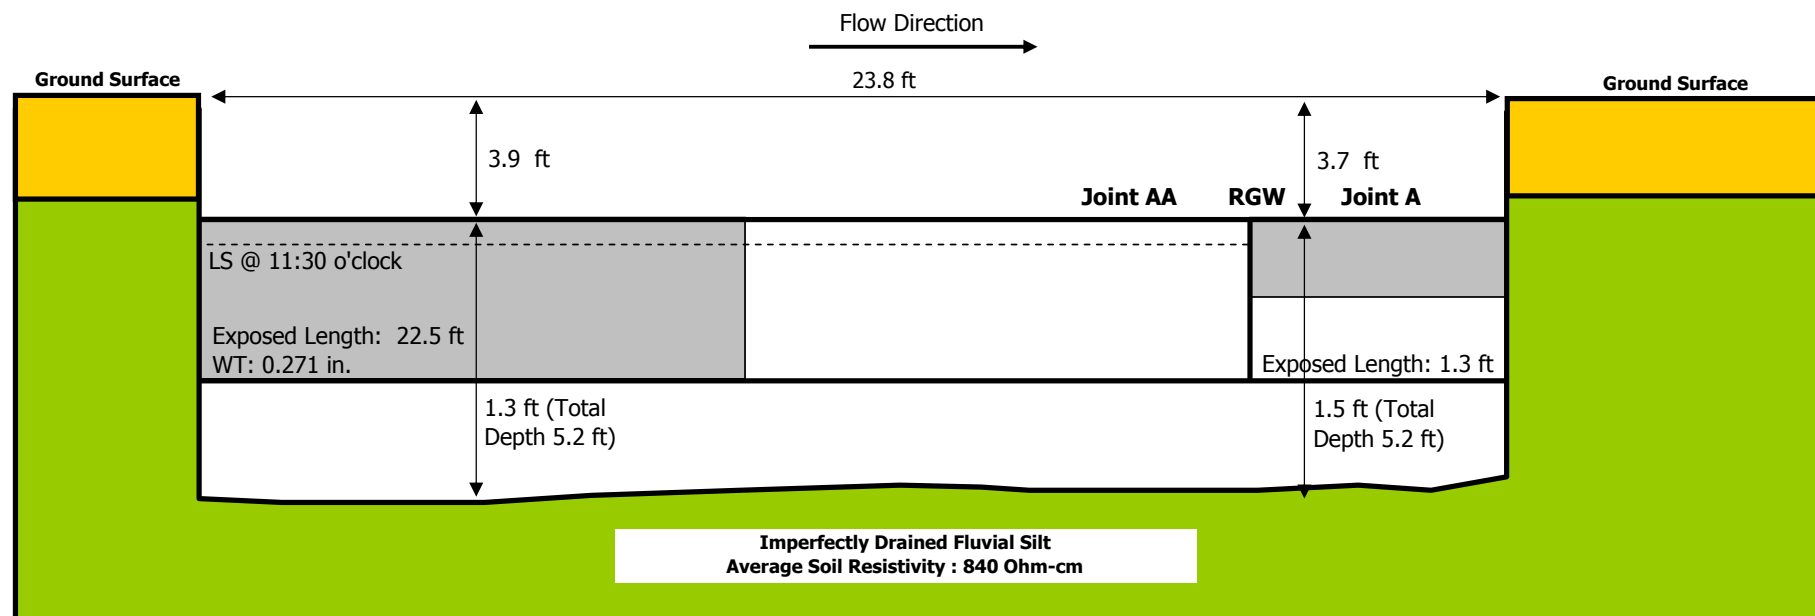
Note: Dashed lines represent the counter clockwise side of the pipe.

Feature Identification	From (ft)	To (ft)	By (in.)	At (in.)	Clock Pipe Position	Length (in.)	Depth (%)
External Corrosion	17.0	17.1	1.0	18.7 CW	1:55	1.2	26.9
External Corrosion	13.62	13.65	0.2	8.1 CW	4:30	0.4	33.9

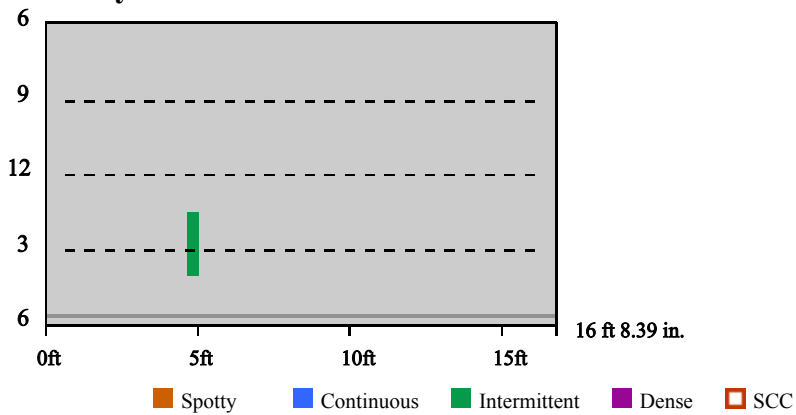
Joint ID: A

Fe-oxide/hydroxide
